# INFRARED INSPECTIONS INC.

Scan Date: 08/01/06 Job No: 06113R-06-37 Client: C.E. Crowley & Associates, Inc.

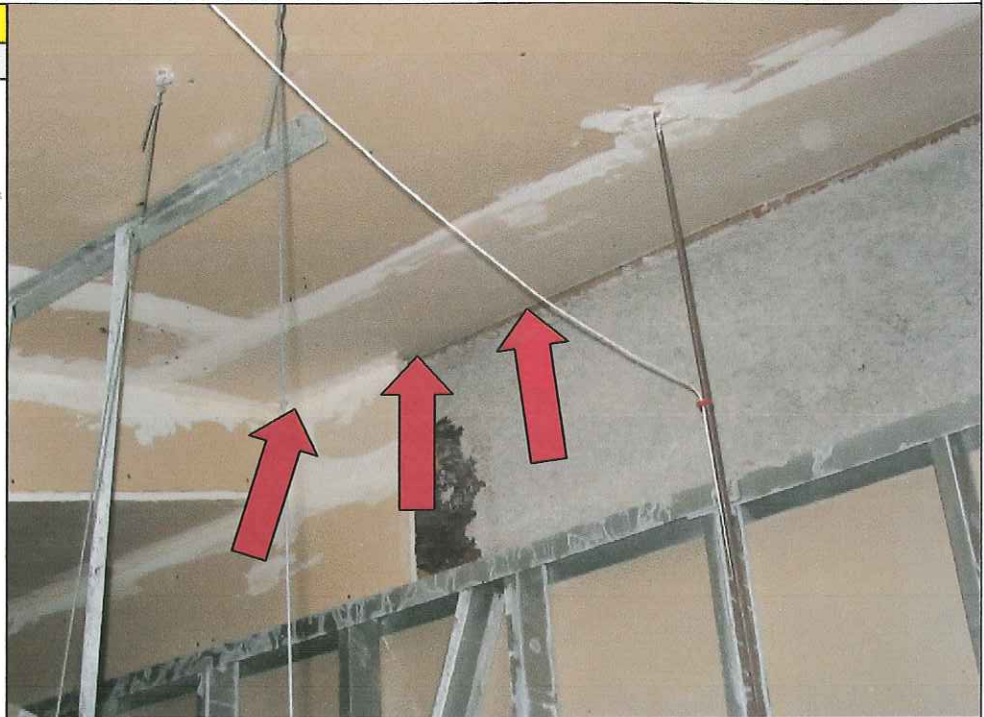
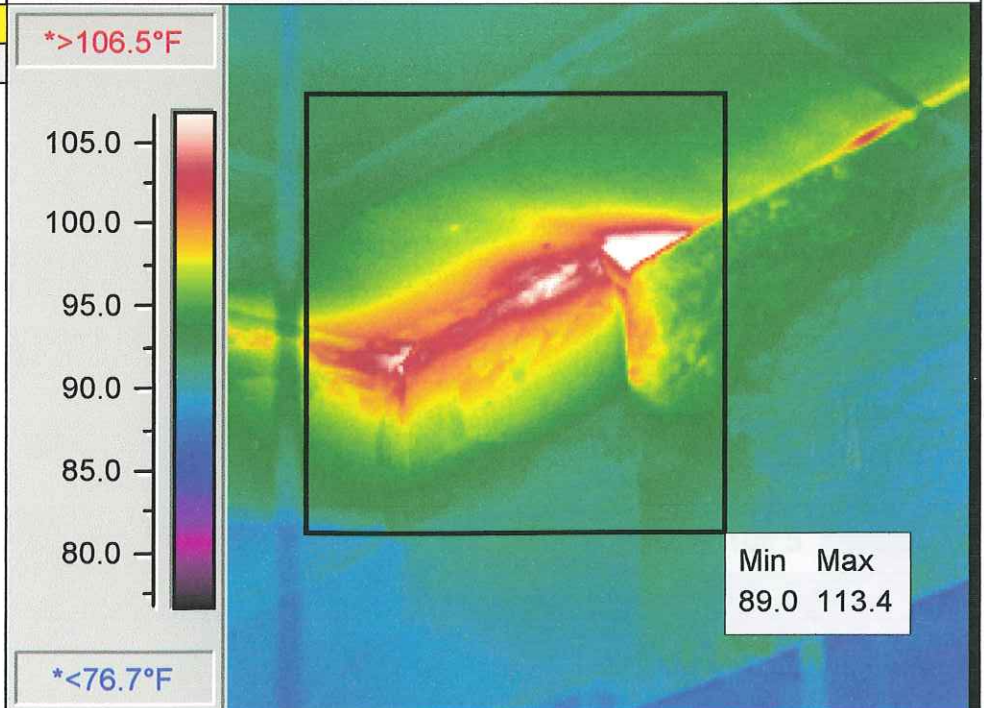
**Location:** Image No. 37 is a view of the 3<sup>rd</sup> floor above drop in ceiling in hallway outside of board room.

**Description:** Image(s) document location (see red arrows in top photo) of building surface thermal differences caused by warm air infiltration. See (below) thermal color photo. Investigation of this area is recommended to determine cause of thermal differences.

Note: Investigation of this area is recommended to determine if corrective action is warranted.

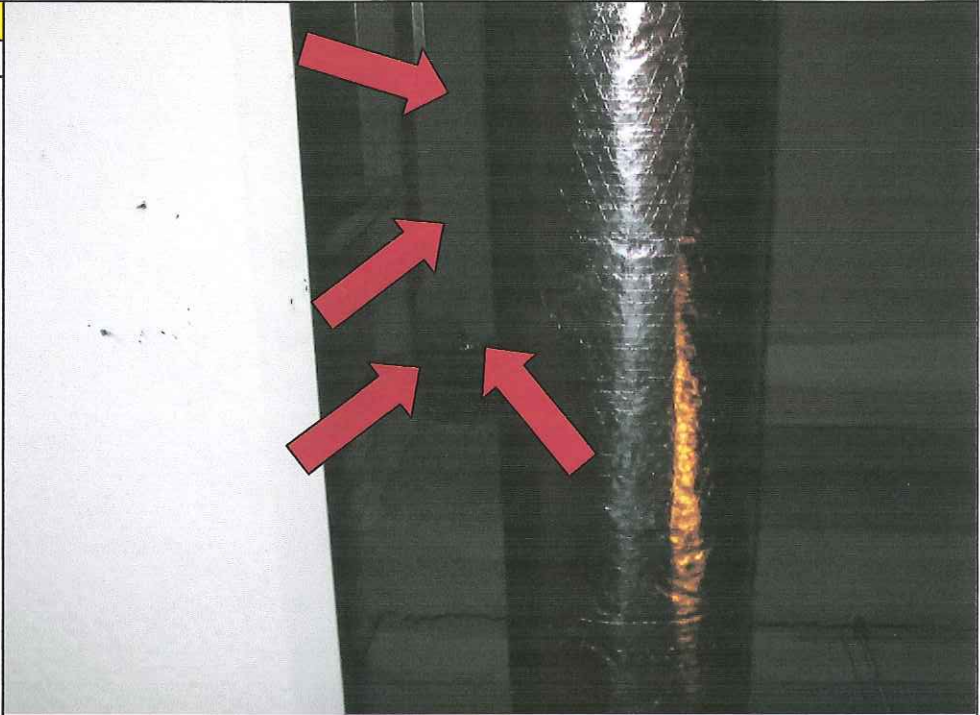
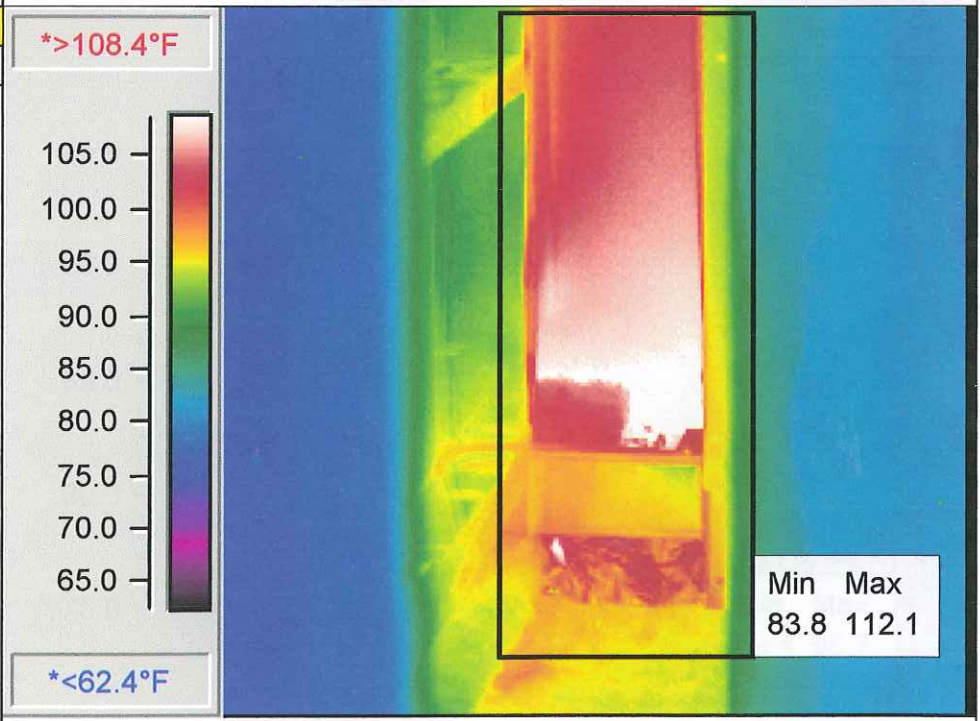
**Location:** Image No. 42 is a view of the 3<sup>rd</sup> floor above drop in ceiling in hallway outside of office area door.

**Description:** Image(s) document location (see red arrows in top photo) of building surface thermal differences caused by warm air infiltration. See (below) thermal color photo. Investigation of this area is recommended to determine cause of thermal differences.

Note: Investigation of this area is recommended to determine if corrective action is warranted.

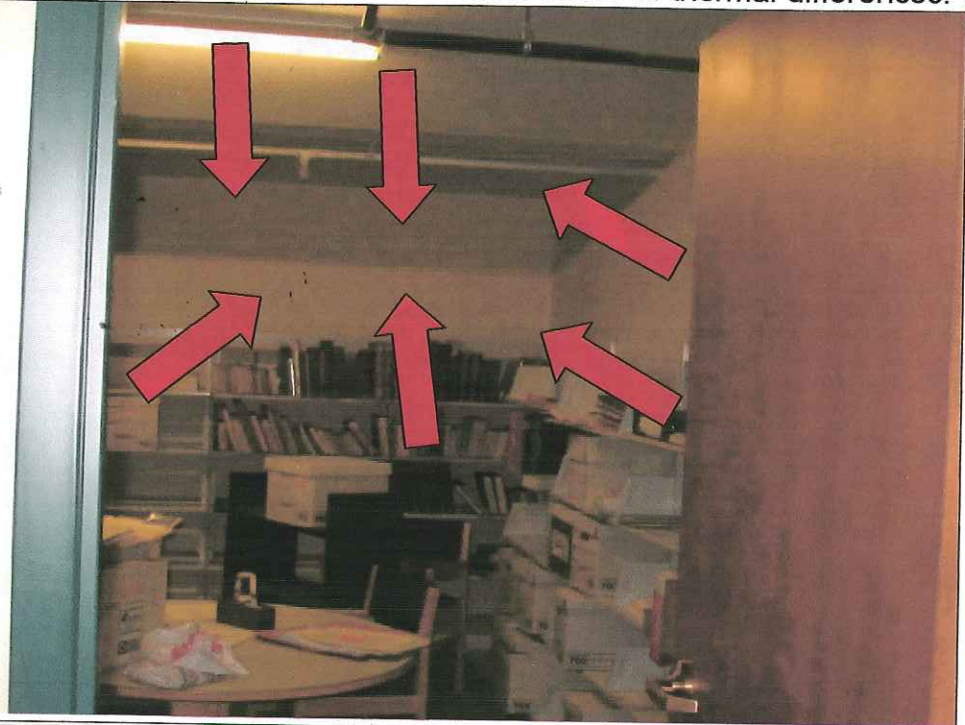
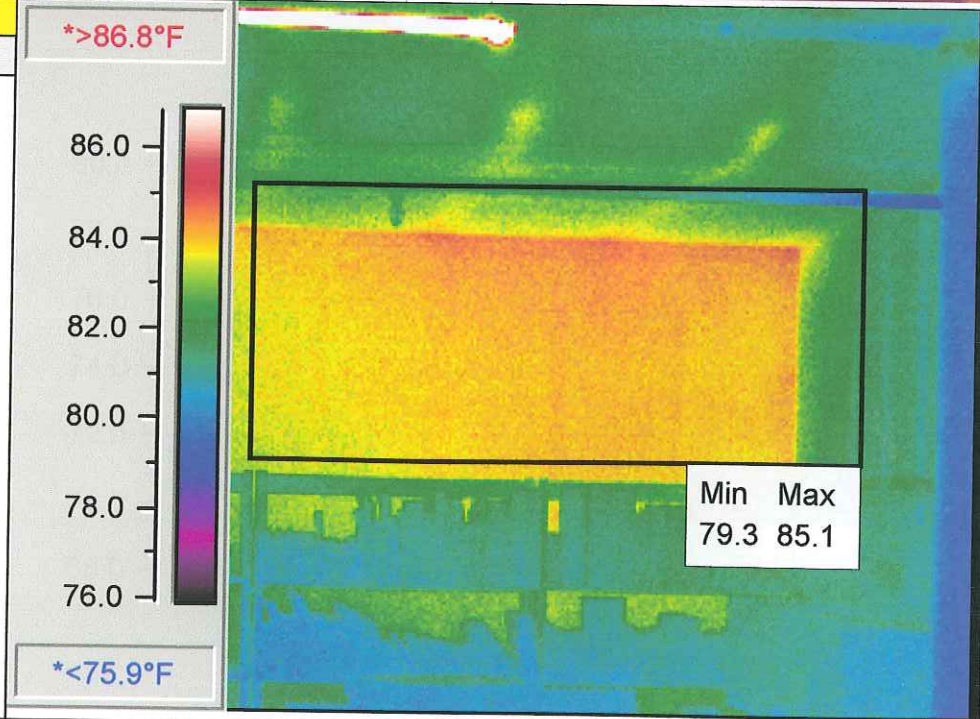
**Location:** Image No. 49 is a view of the 3<sup>rd</sup> floor storage room in computer learning center.

**Description:** Image(s) document location (see red arrows in top photo) of building surface thermal differences caused by warm air infiltration. See (below) thermal color photo. Investigation of this area is recommended to determine cause of thermal differences.

Note: Investigation of this area is recommended to determine if corrective action is warranted.
